**Remedial Action Completion Report for  
Parcels UC-1 and UC-2**

**Hunters Point Naval Shipyard  
San Francisco, California**

**February 2013**

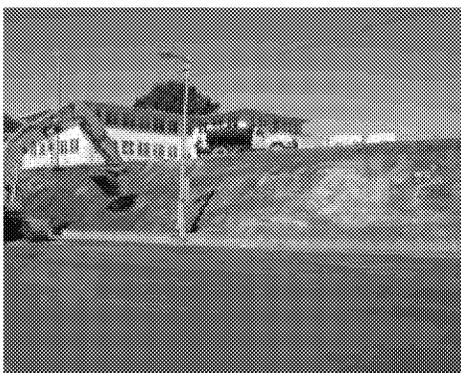
Photograph 5. Exposed bedrock on excavated hillside.

Care was taken to not disturb the bedrock material that was uncovered because the bedrock potentially contains naturally occurring asbestos (photograph 5). Areas where bedrock was encountered are identified in the as-built drawings (Appendix F). Newly exposed hillside soil was stabilized using soil stabilizer and tackifier at the end of each workday to control dust generation.
